## Flue Duct Expansion Joint Inspection 09-04

**EJ-24B**

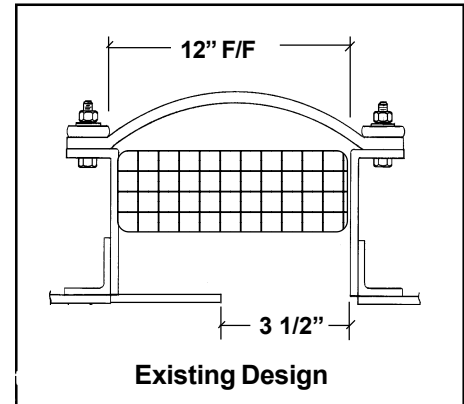
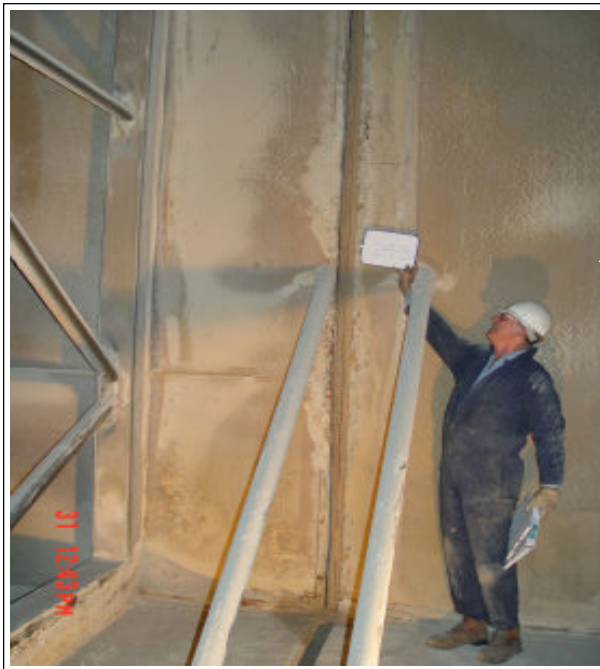
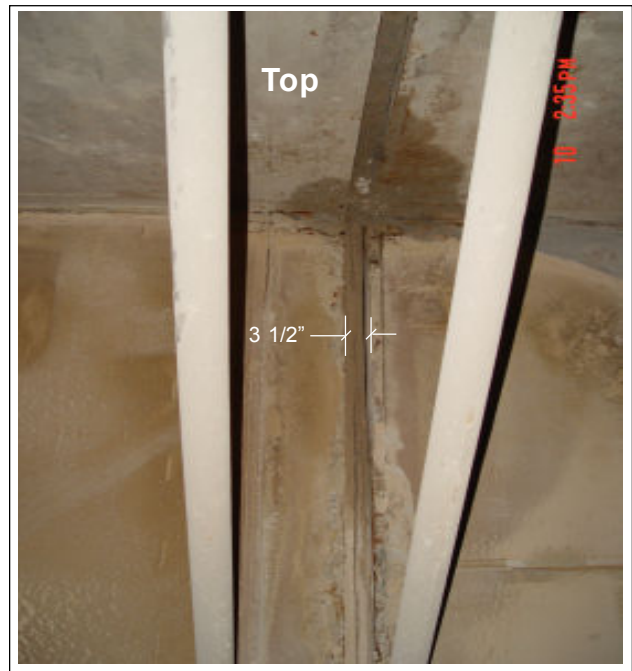
# EJ-24B

Expansion joint shows signs of abrasion to the insulation pillow cover and internal insulation. If left unattended this will result in the premature failure of the expansion joint. The damage was caused by the 3 1/2" gap at the flow liner.

1. Install new 3" high density insulation pillow in the bottom and a 2" pillow on sides & top.
2. Install new 1/4" flow liners that cover entire breach opening on all sides.
