## Flue Duct Expansion Joint Inspection 09-04

**EJ-24B**

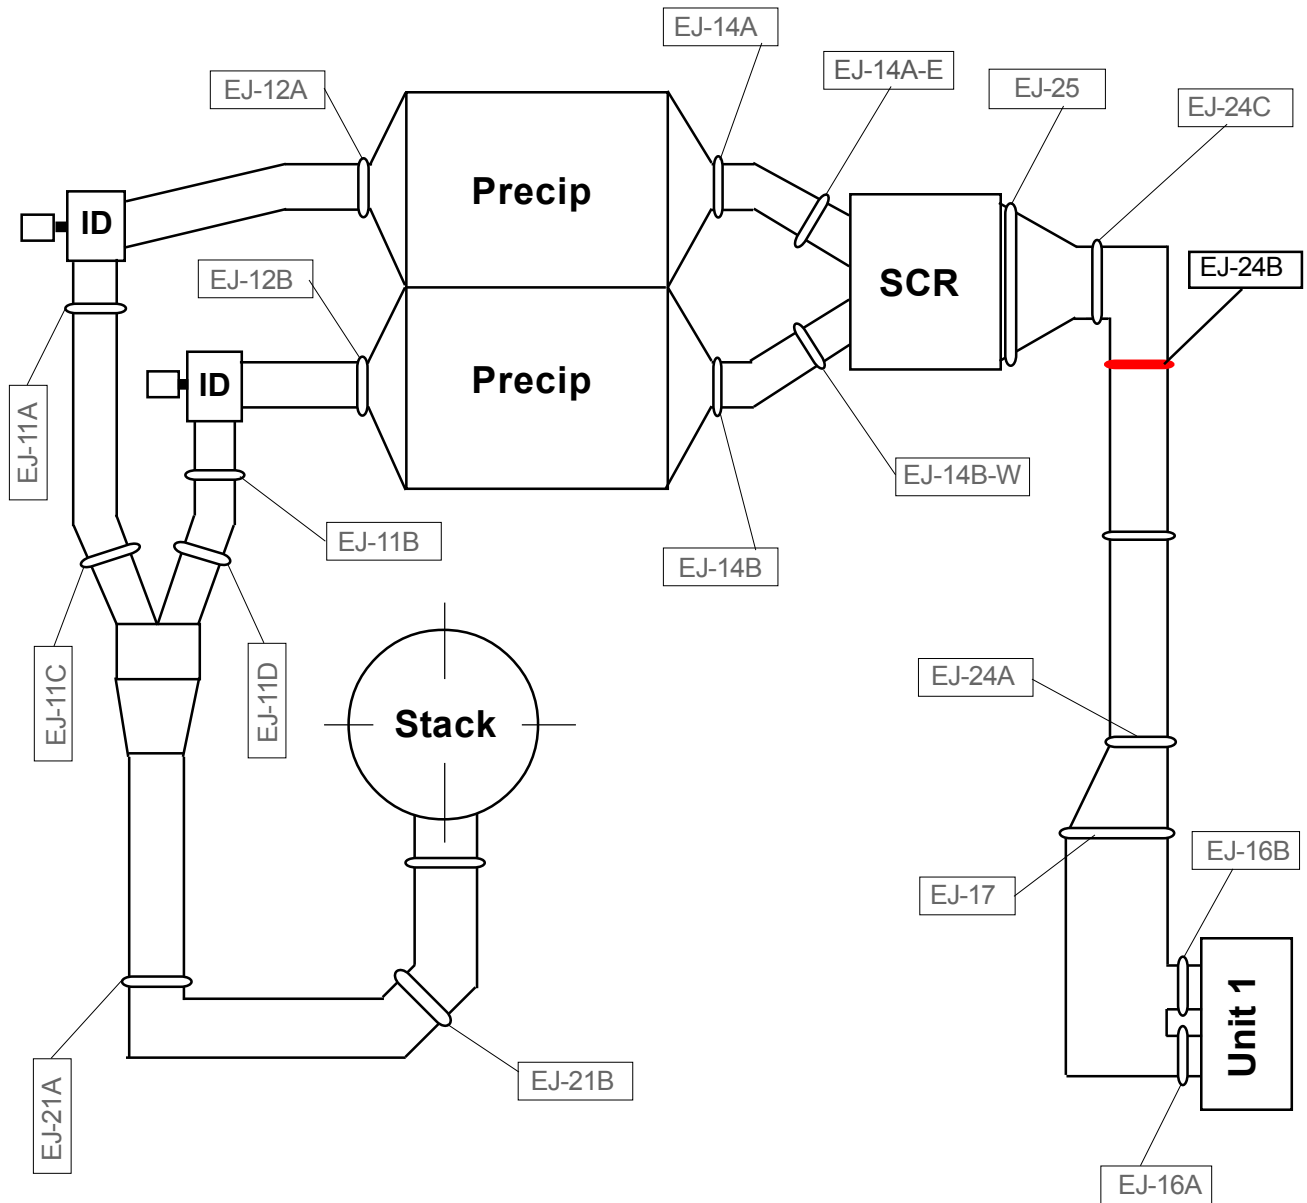
Expansion joint shows signs of abrasion to the insulation pillow cover and internal insulation. If left unattended this will result in the premature failure of the expansion joint. The damage was caused by the 3 1/2" gap at the flow liner.

1. Install new 3" high density insulation pillow in the bottom and a 2" pillow on sides & top.
2. Install new 1/4" flow liners that cover entire breach opening on all sides.
